Fatality #3 - January 18, 2003
Slip/Fall of Person - KY - Limestone
Vulcan Materials Co. - Central Quarry

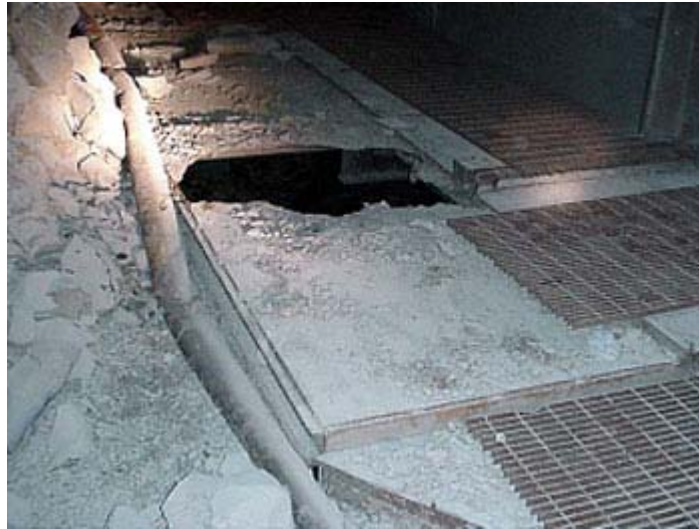
METAL/NONMETAL MINE FATALITY - On January 18, 2003, a 37-year-old supervisor with 16 years 8 months mining experience was fatally injured at an underground crushed stone mine. The victim and a co-worker were re-positioning a water discharge line adjacent to a fan installed on top of a ventilation shaft located on the first level of the mine. The victim stepped on the metal air shaft enclosure. The metal had deteriorated and it failed, causing the victim to fall down the shaft, 143 feet to the second level.

- Ensure that covers installed over openings are substantially constructed, inspected frequently and properly maintained.
- Inspect metal structures located in wet or corrosive environments frequently to identify deterioration that may present a safety hazard.
- Evaluate the integrity and support strength of any cover that was not designed as a walkway prior to walking on it.
- Restrict access to covers over openings that were not specifically designed to serve as travelways.
